DEPARTMENT OF TRANSPORTATION

Contract #: 04-0120F4Cty: SF/ALA Rte: 80 PM: 13.2/13.9File #: 69.28**WELDING INSPECTION REPORT****Resident Engineer:**Pursell, Gary**Address:** 333 Burma Road**City:** Oakland, CA 94607**Report No:** WIR-004457**Date Inspected:** 28-Oct-2008**Project Name:** SAS Superstructure**OSM Arrival Time:** 630**Prime Contractor:** American Bridge/Fluor Enterprises, a JV**OSM Departure Time:** 1530**Contractor:** Zhenhua Port Machinery Company, Ltd (ZPMC), Changxing Island **Location:** Shanghai, China

WELDING INSPECTION REPORT

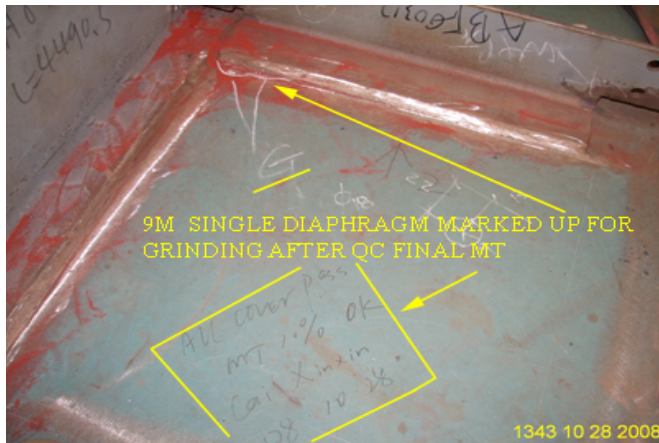
The QA Inspector performed a 10% final Visual (VT) and MT verification on the cover pass of all the welds on Side Plate Sub-Assembly SP724-00 WJ's 001 through 012 (Green Tag 001240) and Bottom Plate Sub-Assembly BP116-001 WJ's 001 through 012 (Green Tag 001241). There appeared to be no indications the QA Inspector accepted all of the above listed welds. The attached photograph provides additional detail.
